Emergency Ambulance Service Reportable Events: April - June 2025

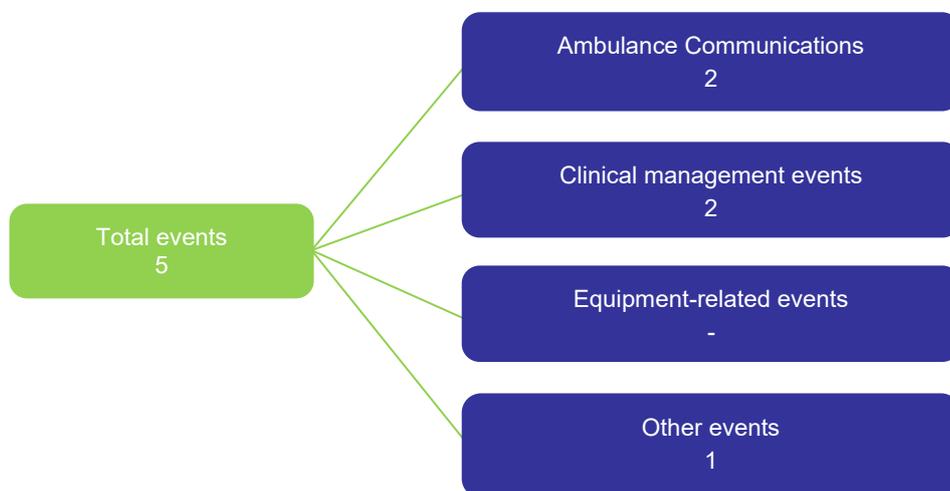
Total number of reportable events and near misses

- Five closed SAC 2 reportable events were reported to NASO for the period.
- 12 SAC 2 reportable events remained open as at the end of the quarter.
