FSN-2021-CC-EC-012

<b>TGA Reference #:</b>	RC-2022-RN-00499-1
<b>Product / Device Name / Model #</b>	Philips M5071A (adult) and M5072A (infant/child) for use specifically with the HeartStart HS1 AEDs/OnSite/Home AED
<b>ARTG Ref #</b>	337264, 374814
<b>Short Problem Description</b>	Adult SMART Pads Cartridge and the Infant/Child SMART Pads Cartridge for use with HS1/OnSite/Home AEDs may experience gel separation and reduction of gel surface area

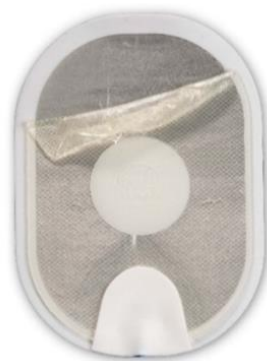
<p><b>1. What the problem is and under what circumstances it can occur</b></p>	<p>HS1/OnSite/Home AED pads (PN: M5071A, M5072A) have been observed to experience gel separation from the foam/tin backing when peeled from the yellow plastic liner. The gel may fold onto itself resulting in reduced surface area of gel on the pad, or it may separate almost completely leaving only a small amount of gel on the pad. Any pad currently installed in or stored with an HS1/OnSite/Home AED could experience this problem, and it is not possible to know prior to patient use if your pad is affected because the pads are protected by a foil seal. Philips has received 115 complaints about this issue since 2010 (of which 84 complaints were received in 2021) for a total of approximately 5 million shipments of M5071A and M5072A pads. Users should continue to use the HS1/OnSite/Home AED and pads as- and follow the voice prompts because the AED will step the user through the necessary actions.</p> <p>The HS1/OnSite/Home AED is intended for use by minimally trained or untrained individuals (e.g., individual homeowners, institutional response team members, teachers, and coaches) to treat victims of suspected sudden cardiac arrest.</p>

<p><b>2. Describe the hazard/harm associated with the issue</b></p>	<p>When a pad with separated, folded gel is placed on the patient's bare skin, the HS1/OnSite/Home AED could deliver less effective or ineffective therapy to the patient due to the reduced surface contact area with the skin. See example picture in <b>Figure 1</b>.</p> <p>Separated, folded gel may also have a discolored and/or melted appearance. While the gel may also have a discolored and/or melted appearance, the appearance does not have any impact on the delivery of therapy; however, there may be a delay in therapy if the user hesitates to apply the pad due to its appearance, and the AED may deliver less effective or ineffective therapy to the patient due to the reduced contact area with the skin. See example picture in <b>Figure 2</b>.</p> <p>It is also possible that the gel could separate almost completely from the foam/tin backing when peeled, (see <b>Figure 3</b>.) Due to a small amount of gel surface contact area with the skin, electrical arcing could occur when a shock is delivered leading to burns to the patient's skin, or the AED could be unable to deliver any shock through the pads. A delay in therapy will result while the user installs a replacement pads cartridge (if available) or performs CPR while waiting for Emergency Medical Services Personnel to arrive. For comparison, <b>Figure 4</b> shows a normal pad. No matter the state of the pad, follow the voice prompts because the AED will step you through the necessary actions.</p> <p style="text-align: center;"><i>(continued to next page)</i></p>

**Figure 1:** Separated gel that has folded onto itself when peeled.

**Action:**  
Apply pads to the patient.  
Do not hesitate.

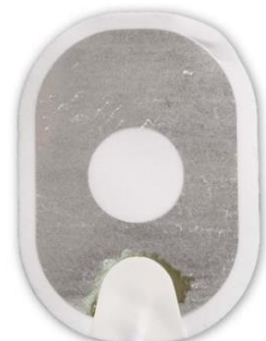
**Figure 3:** Gel almost completely separated from backing.

**Action:**  
Replace pads cartridge if a spare is available. If no spare is available, perform CPR until help arrives.

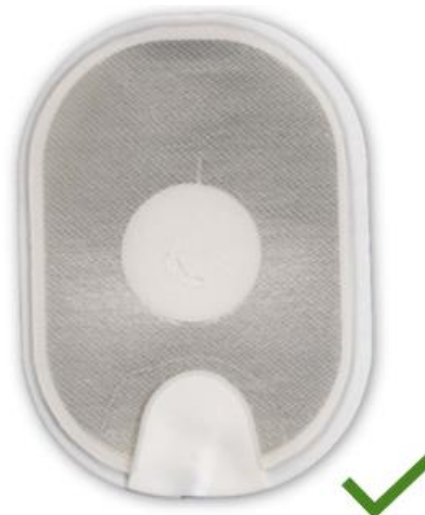
**Figure 4:** Normal pad.

**Action:**  
Apply pads to the patient according to the Instructions for Use/Owner's Manual.
